CLAM LAKES, BURNETT COUNTY

2022-26 AQUATIC PLANT MANAGEMENT PLAN
WDNR WBIC: 2656200 & 2655300

Prepared by: Lake Education and Planning Services, LLC
Cameron, WI 54822
Dave Blumer, Lake Educator
October, 2021

CLAM LAKE PROTECTION &
REHABILITATION DISTRICT
SIREN, WI 54872

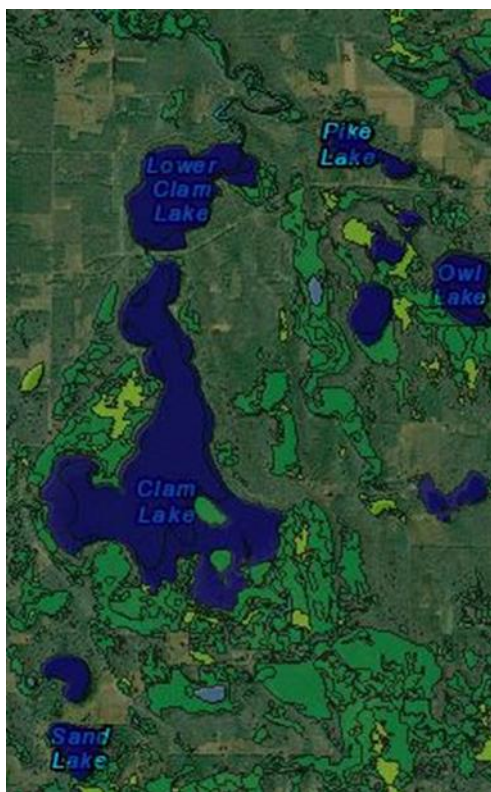
Figure 3: Clam Lakes wetlands (4)

According to the National Wetland Inventory, emergent, forested/shrub and freshwater, emergent wetlands are present in the Clam Lakes watershed. The majority of the wetland borders the lakes and tributary streams and have a direct hydrologic connection to the lakes (Figure 3). Emergent wetlands (light green) are wetlands with saturated soil and are dominated by grasses such as redtop and reed canary grass, and by forbs such as giant goldenrod. Forested/shrub wetlands (darker green) are wetlands dominated by mature conifers and lowland hardwood trees. Forested/shrub wetlands are the dominant form of wetlands in the watershed and are important for stormwater and floodwater retention and provide habitat for various wildlife.

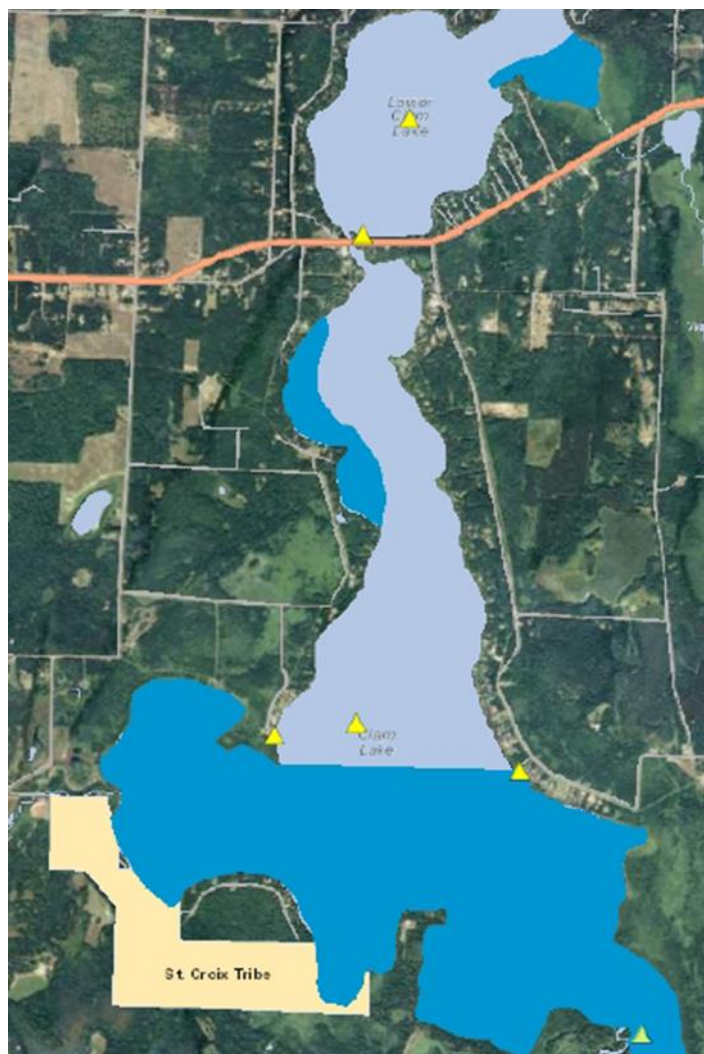
Figure 4: Sensitive areas (dark blue) in Upper and Lower Clam lakes (5)

The WDNR mapped sensitive areas on the Clam Lakes in 1997 (Figure 4). The full report is included in Appendix C. The Sensitive Area survey identified three areas on Upper Clam Lake and one area on Lower Clam Lake. These areas of aquatic vegetation on Clam and Lower Clam Lake offer critical or unique fish and wildlife habitat. These habitats provide the necessary seasonal or life stage requirements of the associated fisheries, and the aquatic vegetation offers water quality or erosion control benefits to the body of water.

The data and recommendations from the Sensitive Area Report were reviewed and incorporated into this management plan. In addition to site-specific recommendations, the report recommends that aquatic vegetation should be protected and any removal or control should be minimized. In sensitive areas, it is important to maintain vegetated shoreland buffers. Stumps and woody habitat, which provide fish cover, should not be removed from sensitive areas.

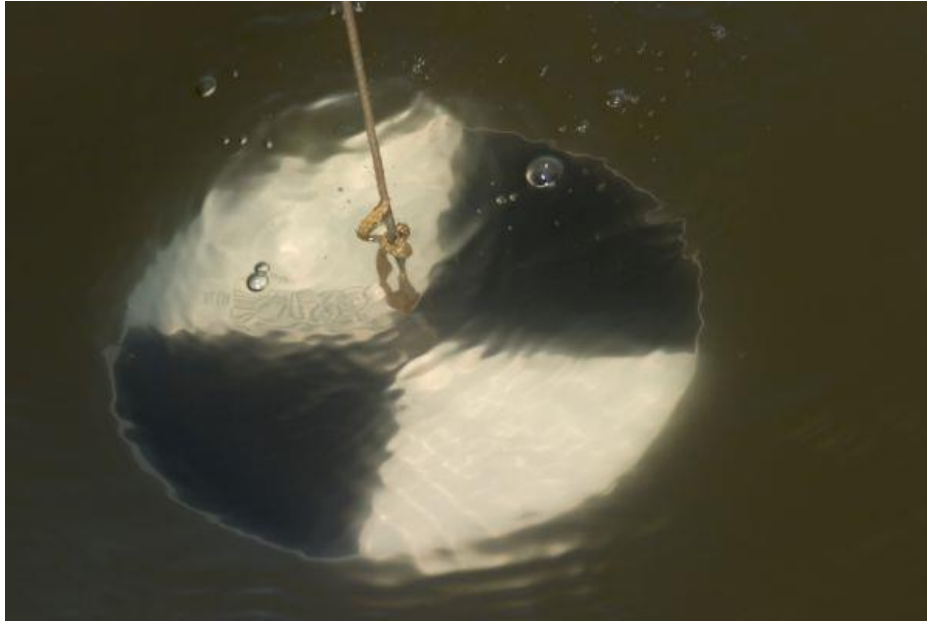
Figure 8: Black and white Secchi disk

Water clarity is a measurement of how deep sunlight can penetrate into the waters of a lake. It can be measured in a number of ways, the most common being an 8” disk divided into four sections, two black and two white, lowered into the lake water from the surface by a rope marked in measurable increments (Figure 8). The water clarity reading is the point at which the Secchi disk when lowered into the water can no longer be seen from the surface of the lake. Water color (like dark water stained by tannins from nearby bogs and wetlands), particles suspended in the water column (like sediment or algae), and weather conditions (cloudy, windy, or sunlight) can impact how far a Secchi disk can be seen down in the water. Some lakes have Secchi disk readings of water clarity of just a few inches, while other lakes have conditions that allow the Secchi disk to be seen for dozens of feet before it disappears from view.

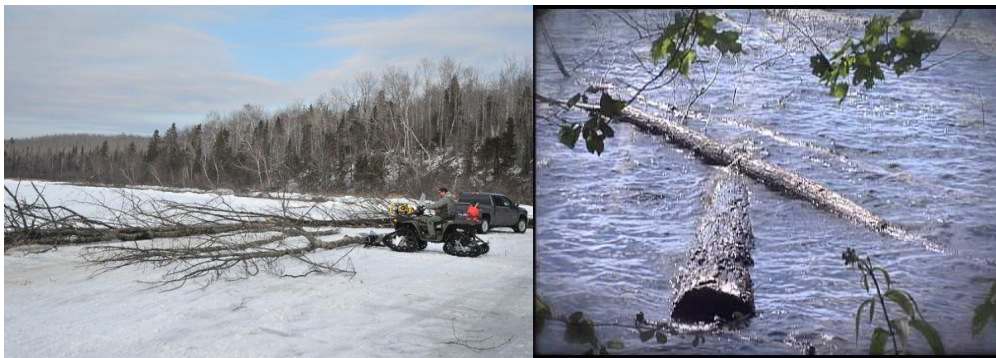
Figure 18: Coarse woody habitat-Fishsticks projects

Fortunately, remediation of this habitat type is attainable on many waterbodies, particularly where private landowners and lake organizations are willing to partner with county, state, and federal agencies. Large-scale CWH projects are currently being conducted by lake groups and local governments with assistance from the WDNR where hundreds of whole trees are added to the near-shore areas of lakes. For more information on this process visit: <http://dnr.wi.gov/topic/fishing/outreach/fishsticks.html> (last accessed on 1-4-2018). These types of projects are more formally called “tree drops” but are popularly are called “fish sticks” (Figure 18).

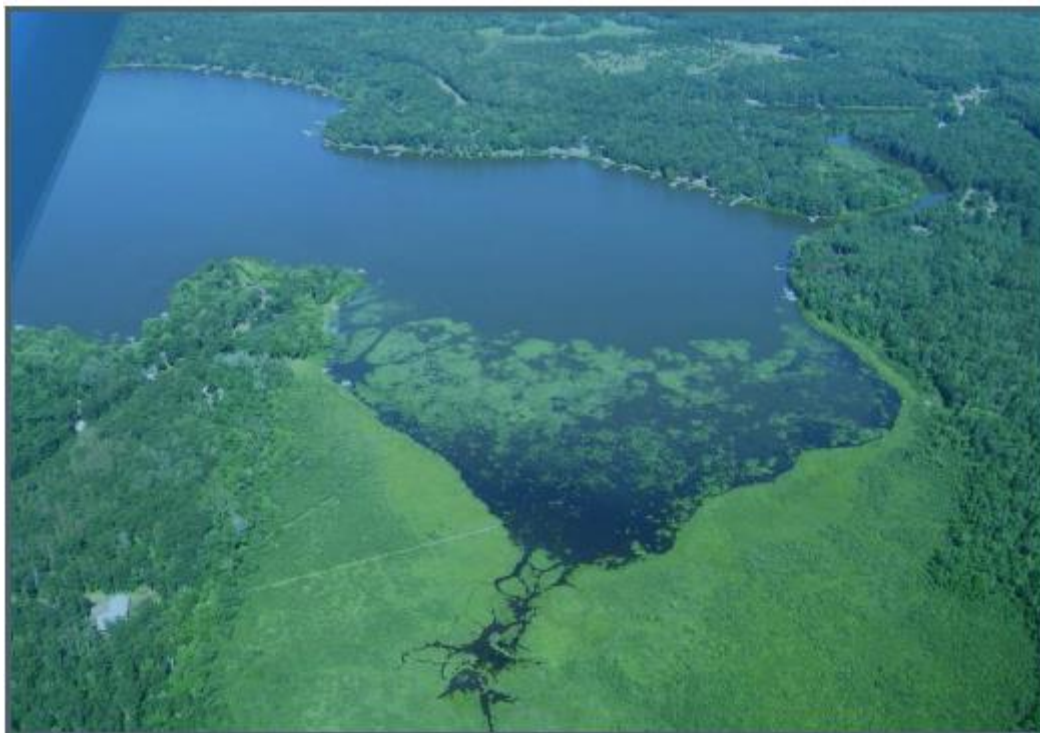
Figure 39: Wild rice in the bay east of the outlet on Lower Clam Lake in 2008 (GLIFWC, 2010)

Although Upper Clam Lake is well known for its expansive rice beds, the smaller beds on Lower Clam tend to be overlooked. The rice on Lower Clam is largely limited to the bay east of the outlet which is visible at the upper right in the photo in Figure 39. There are anecdotal reports that these beds were seeded by local residents fairly recently. They are located in an area with little lakeshore development. It remains to be seen if these beds are facing the same decline that has been witnessed on the Upper Clam beds, whose most recent appreciable crop was in 2006. The Tribal Watch Status for Lower Clam is high due to decline concerns.

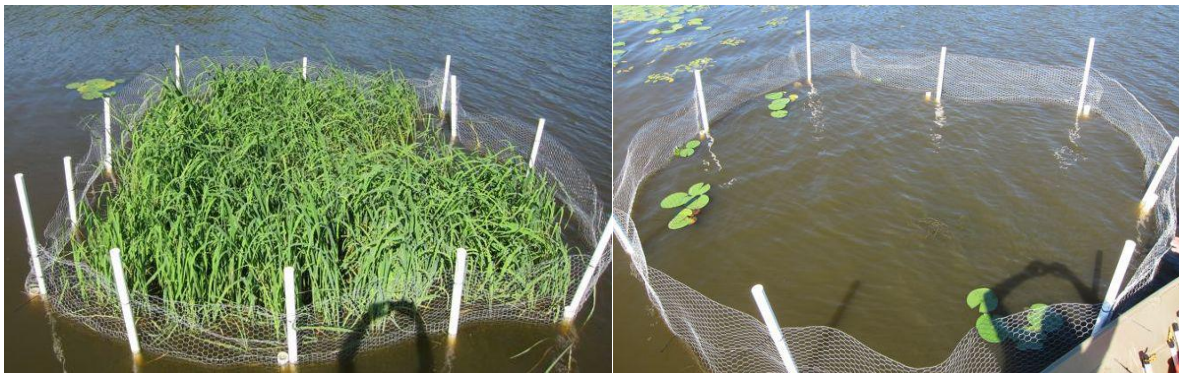
Figure 42: Seeded and fenced (left) and unseeded and fenced (right) wild rice enclosures installed in 2010

A meeting was held on January 19, 2010 at the Tribal Resources Office in Hertel, WI to discuss 2009 findings on the Clam Lakes and what to do in 2010. The local WDNR Fish Manager, SCTES biologists, GLIFWC Biologists, Clam CLPRD representatives, SEH, and others were in attendance. Additional carp studies were completed in 2010 by both the WDNR and Tribal Resources. SCTES also completed a more comprehensive wild rice survey of the system in 2010. In another study completed in 2010 (22), a system of carp exclusion cages were set up by SCTES and WDNR resources in Upper Clam Lake in an attempt to determine what impact the carp may be having in the system. Several of the cages were seeded with rice (Figures 42 & 43).

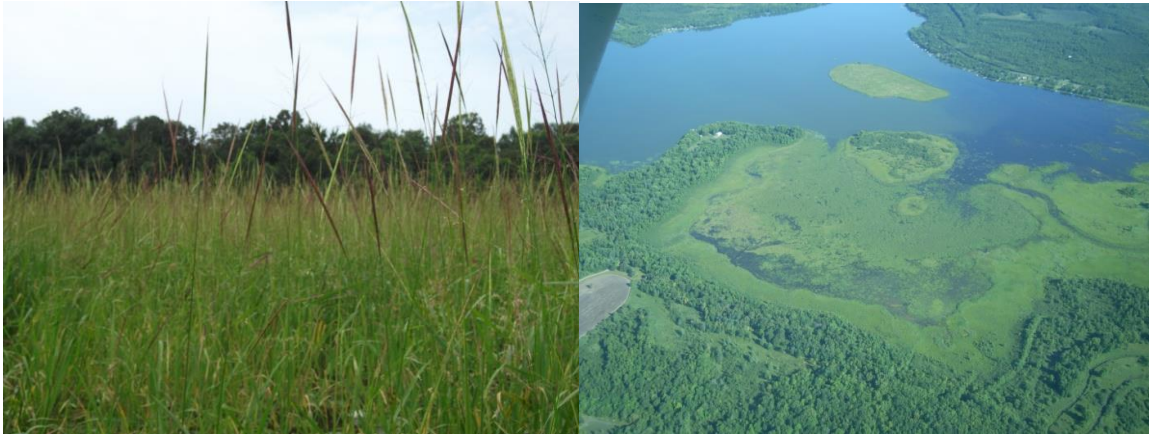
Figure 45: Wild rice in the SE Bay of Upper Clam Lake in 2012 (left, ERS) and 2013 (right, GLIFWC)

The recommendation to keep the carp barrier across the southeast bay of Upper Clam Lake was heeded and in each of the last two years they have been reinstalled in the spring of the year before carp have a chance to move into the area. Survey work done in 2012 and again in 2013 show that by keeping carp out of the SE Bay, the wild rice has rebounded nicely (Figure 45). Further consideration should be given to fencing carp out of other areas of both lakes to help restore wild rice and other native plants.

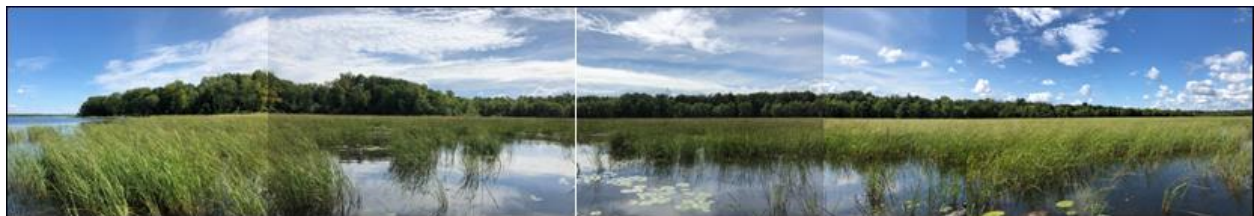
Figure 47: Panorama of northern wild rice in the SW bay facing southwest 8/31/19 (Berg, 2019)

Broken out by region, the southwest bay had more rice than at any point since the first survey in 2009. Viewed from Lone Star Road on the bay's southwest side, a wall of rice extended out from shore (Figure 47). On the open water margin, the rice was more fragmented, but the majority of areas were still extremely dense (Figure 20), and harvest trails crisscrossed the bed.

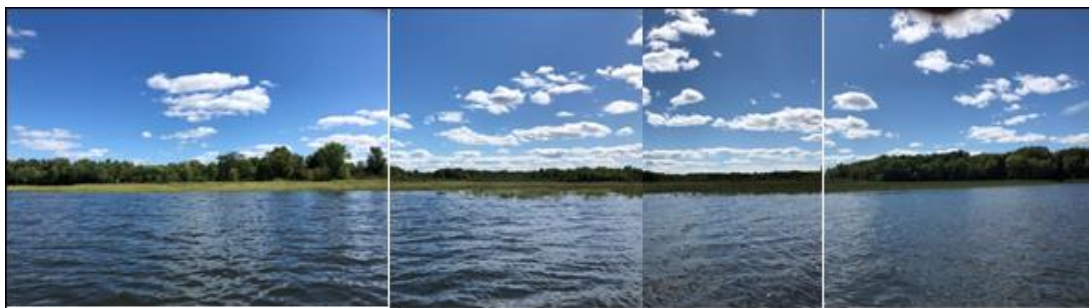
Figure 48: Panorama of northern wild rice in the south-central bay 8/30/19 (Berg, 2019)

The south-central bay also had harvestable density. A nearly continuous wall of plants reached the landing on the southwest side of the bay and stretched almost uninterrupted back up the creek inlet (Figure 48).

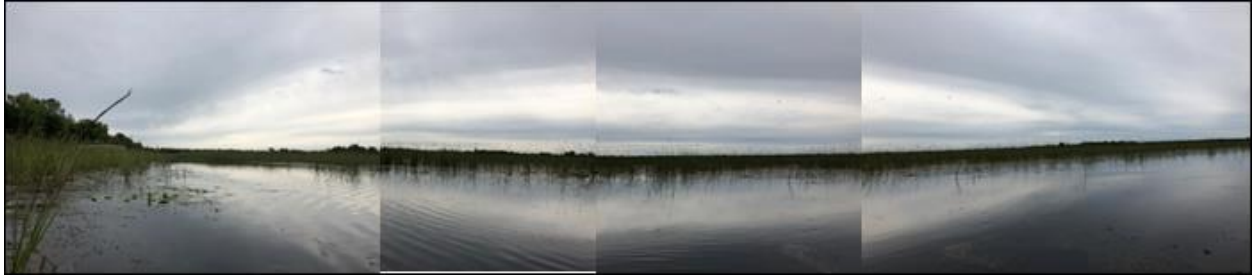
Figure 49: Panorama of north shoreline in the SE bay facing east towards the river inlet 8/31/19 (Berg, 2019)

In the southeast bay, much of the river inlet was impassable by canoe and nearly so by kayak as it took an entire day to survey 50 points in this area. Along the north shoreline, residents seemed to be having significant difficulty keeping a path open as both the patchy rice and submergent vegetation made motor travel difficult (Figure 49).

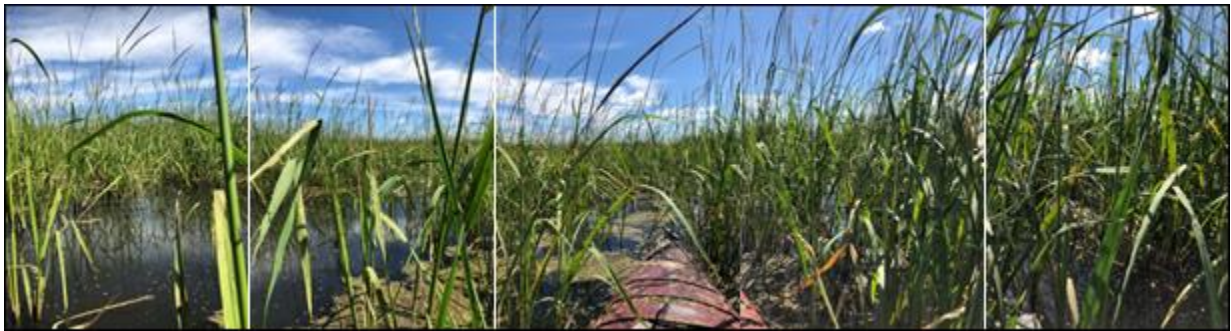
Figure 50: Panorama of northern wild rice from SE side of former enclosure facing south 9/2/19 (Berg, 2019)

Wild rice created an almost impenetrable wall that was only accessible by kayak in the entrance to the SE bay south of the river inlet. This area is in the former carp enclosure area (Figure 50). Density was high throughout most of the bay, but a sizable area of open water was found in the southwest corner of the bay (Figure 51).

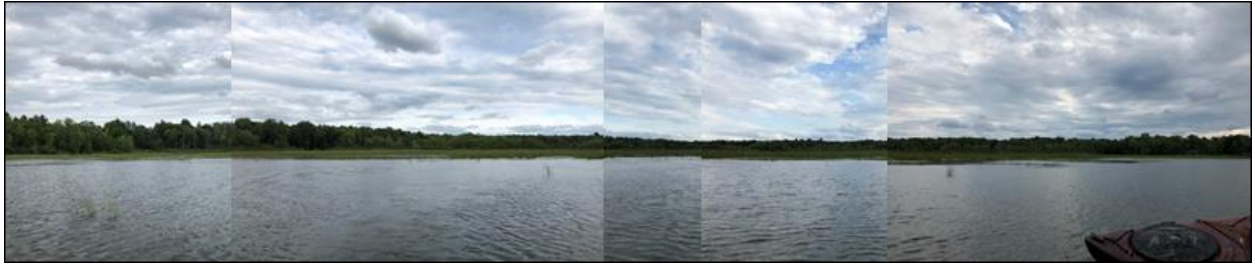
Figure 53: Panorama of northern wild rice in SE corner of east bay facing SE - 8/25/19 (Berg, 2019)

In 2019, rice underwent a further non-significant expansion to 15 points with five additional visual sightings. Conversely, its density saw a nearly significant decline to a mean rake fullness of 2.00 (Figure 52). The west side of the bay (Figure 53) continued to be somewhat patchy, but the eastern side was so dense that the beds offered significant human harvest potential, albeit over a relatively small area (Figure 54).

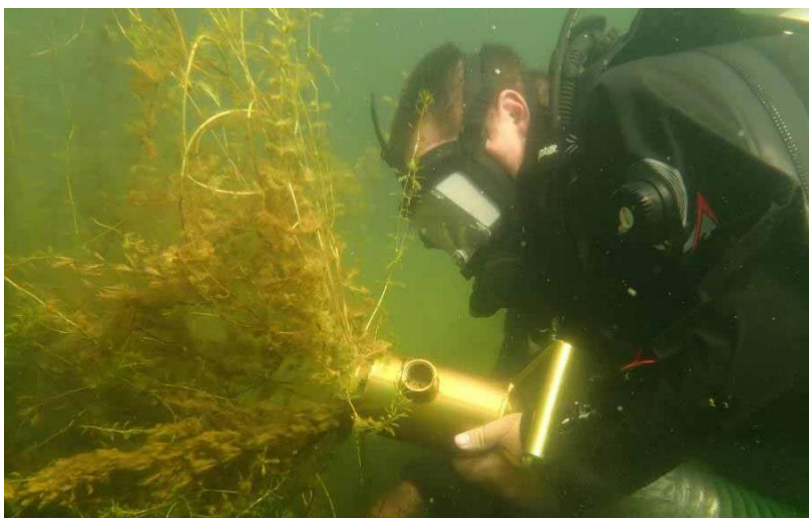
Figure 66: DASH - Diver Aided Suction Harvest (Chuck Druckery, 2016 Wisconsin Lakes Convention Presentation)

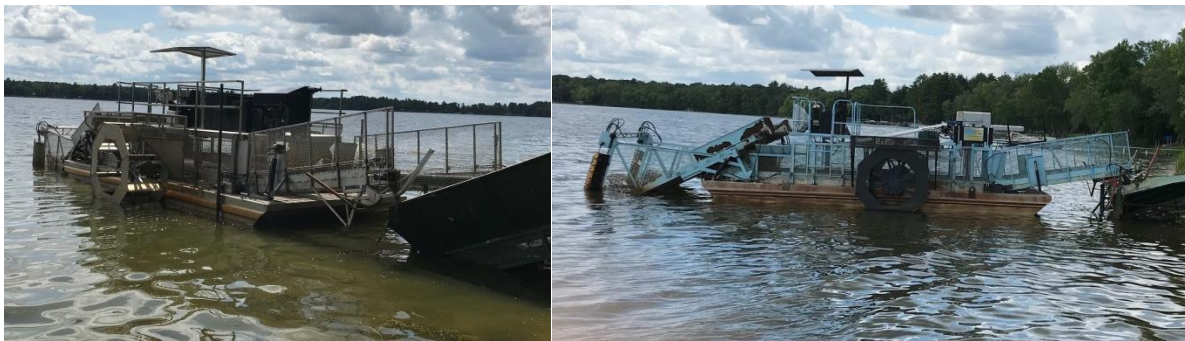
Figure 68: Two harvesters owned and operated by the CLPRD

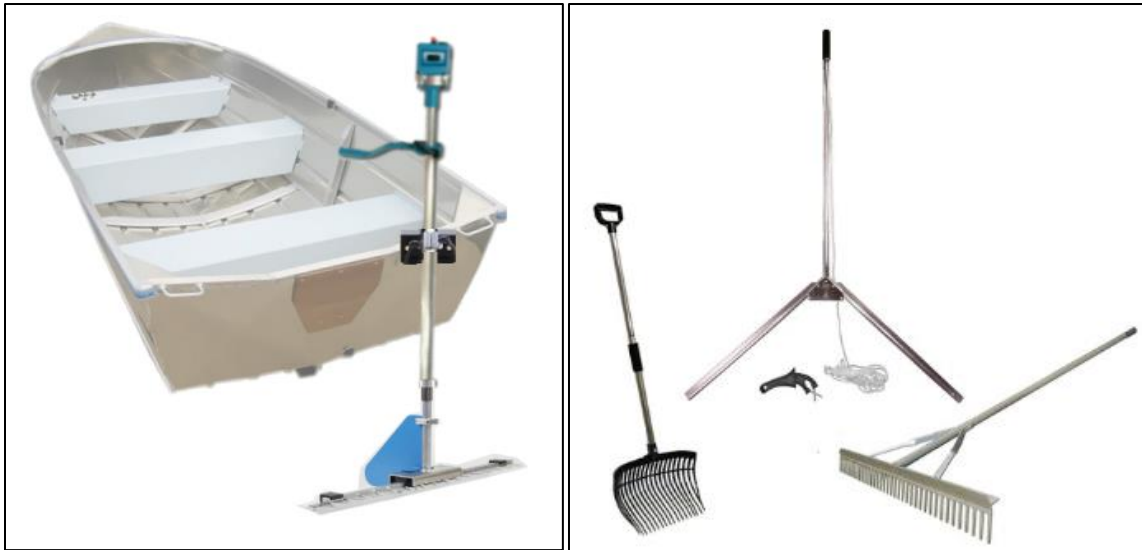
Figure 69: Aquatic Mower & Weedshear Weed Cutter (weedersdigest.com)

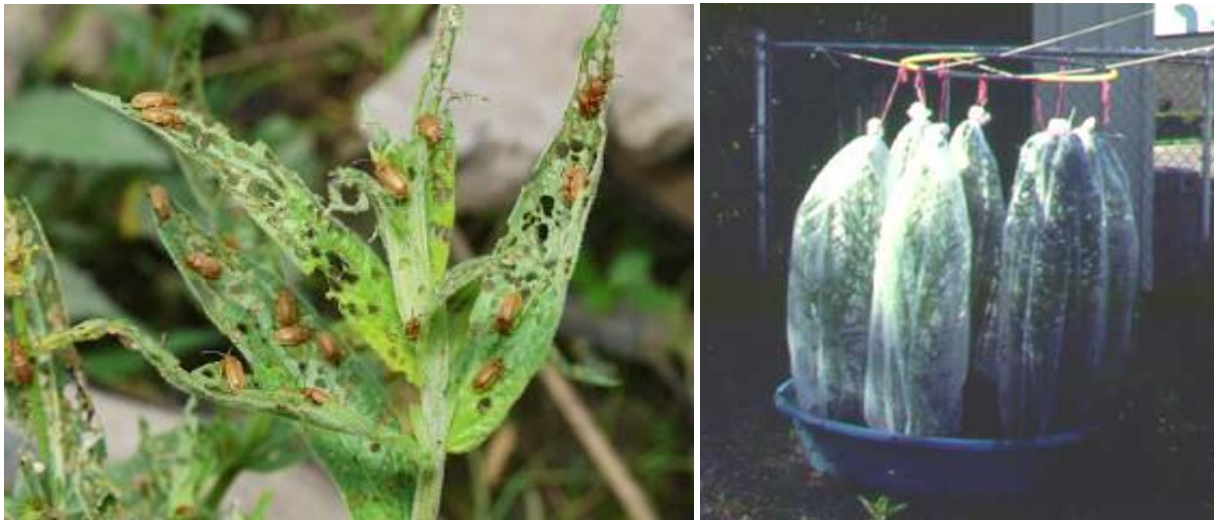
Figure 70: Galerucella beetles that eat purple loosestrife and a “backyard” beetle rearing station

Purple loosestrife is another invasive species that has been identified in and around the Clam Lakes. Biological control in the form of a beetle (Figure 70) that eats purple loosestrife and that can be raised and

distributed locally is a recommended management action, particularly if the distribution and density of purple loosestrife expands in the lakes. Individual plants and small infestations of purple loosestrife can be controlled manually by pulling and/or cutting. Selective application of herbicides by dabbing cut stems can also be used.

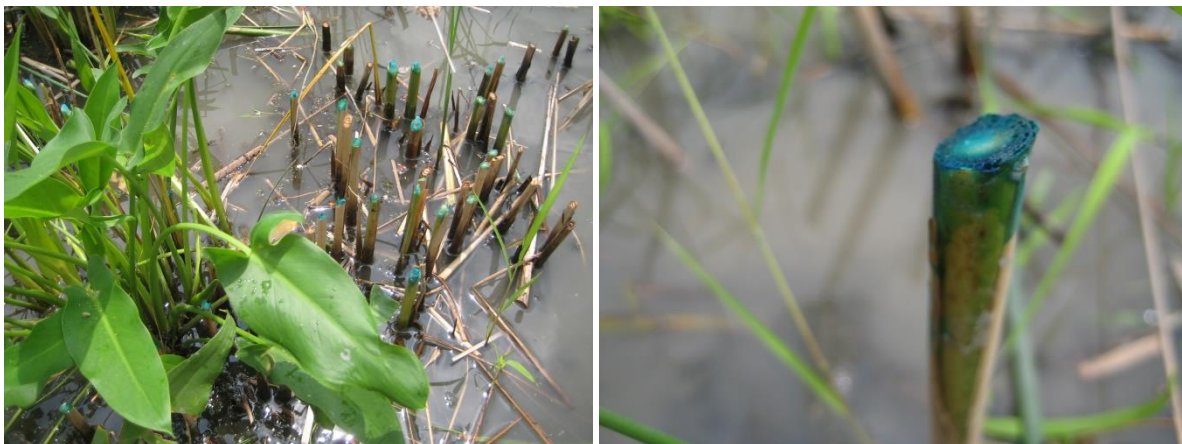
Figure 71: Cut stem or herbicide “dabbing” to control AIS (

Herbicides may be considered for control of purple loosestrife provided it is “dabbed” on to the cut stem of the plant (Figure 71). This method is carried out by cutting stems of target species within two to four inches of the ground followed by application of herbicide, usually a Glyphosate based solution, to the cut surface. When treating larger stumps (>2 in.) herbicide should be applied to the outer edge of the stump, while smaller stumps (<2 in.) should be treated across the entire top surface. Treatment should occur immediately following cutting to ensure proper absorption of herbicide. A colored dye is usually added to the solution so that it is clear where the herbicide has been applied.

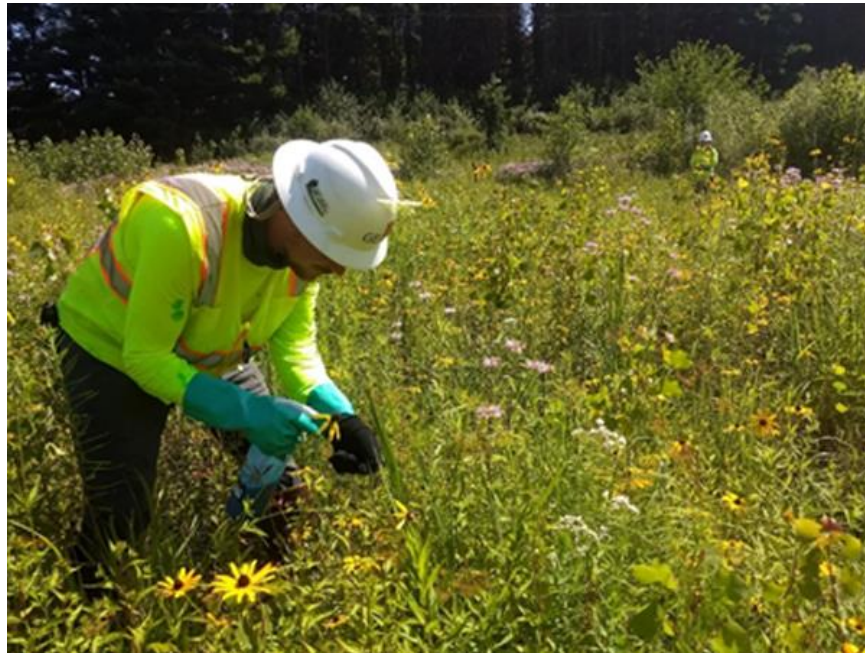
Figure 72: Hand wicking invasive species with herbicide

Another method of herbicide use that could be considered is hand wicking. Hand wicking involves spraying an herbicide solution on an absorbent glove and carefully wiping the herbicide onto the surface of a leaf (Figure 72). It’s important to wear an herbicide resistant glove beneath the absorbent glove, to protect your

hand from the herbicide. This method is appropriate when controlling small populations of invasive species that are growing in a high-quality area, or when controlling invasive species in close proximity of endangered or threatened native species (<https://muskegonlake.org/habitat-management-plan/invasive-species-control/>, last accessed on August 6, 2020)

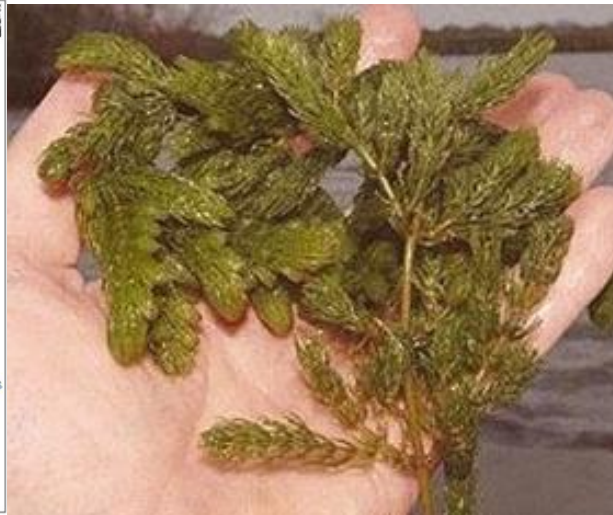
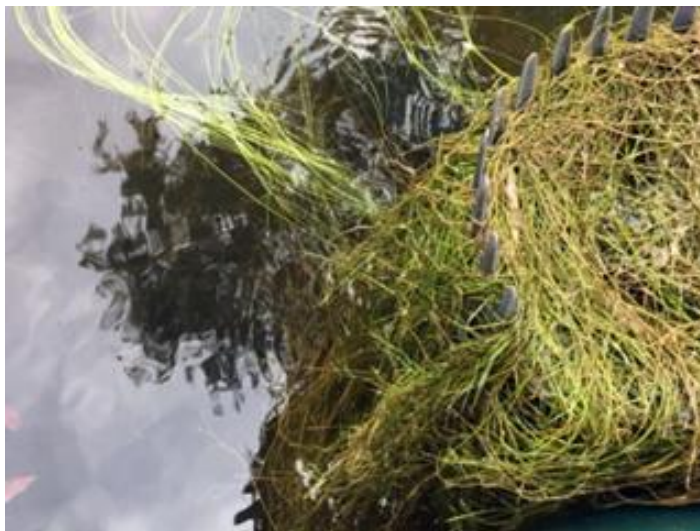
Figure 78: Distribution and density of coontail, small pondweed, common waterweed, water star-grass, and water celery (Berg, 2019)

In Upper Clam Lake, the most abundant native aquatic plant species in 2019 were coontail, small pondweed, common waterweed, water star-grass, and water celery (Figures 78). All five of these species, while considered part of a healthy native plant community, can cause nuisance conditions and navigational impairments by entangling around boat props, anchors, and fishing lures; and interfere with swimming and other recreational uses. All of these species are located throughout the lake but they are particularly dense along the southeast shore, and in the two bays on the northwest side of the lake. Like Lower Clam Lake, management of these species is needed only to open navigation lanes that will maintain access to open water for the numerous property owners adjacent to large beds of these species. Cutting fairly wide navigation channels parallel to the shore at a distance from shore that coincides with the ends of docks; and cutting several access lanes perpendicular to shore through dense beds of vegetation to open water is recommended.

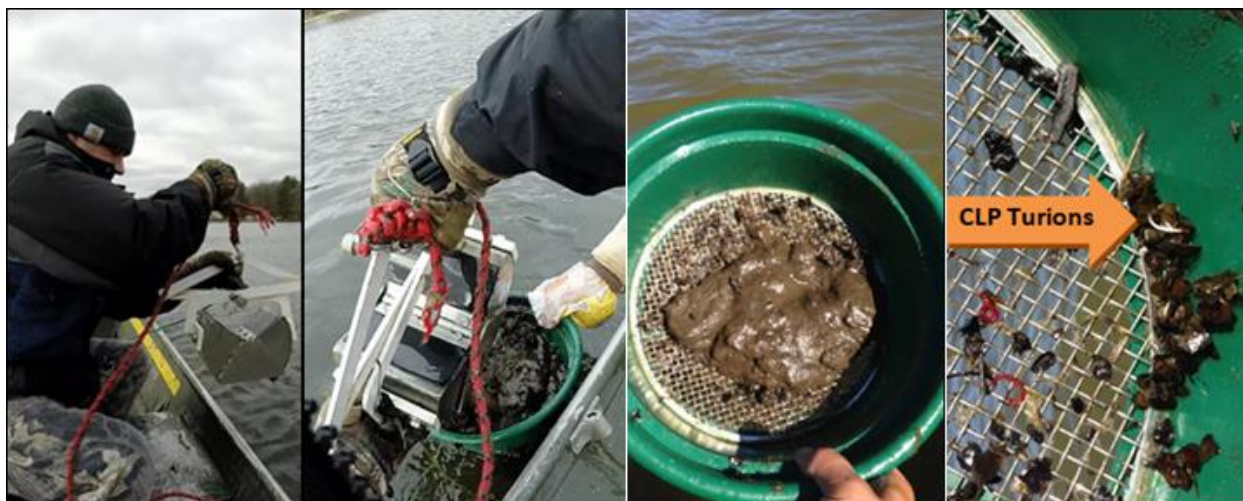
Figure 80: CLP turion density sampling (photo credits – Matt Berg)
