Clam Lakes - Interim Lake Management Plan

Aquatic Plant/Water Quality Management

Burnett County, Wisconsin

DNR No. LPL-1318-10
SEH No. CLAML 106825

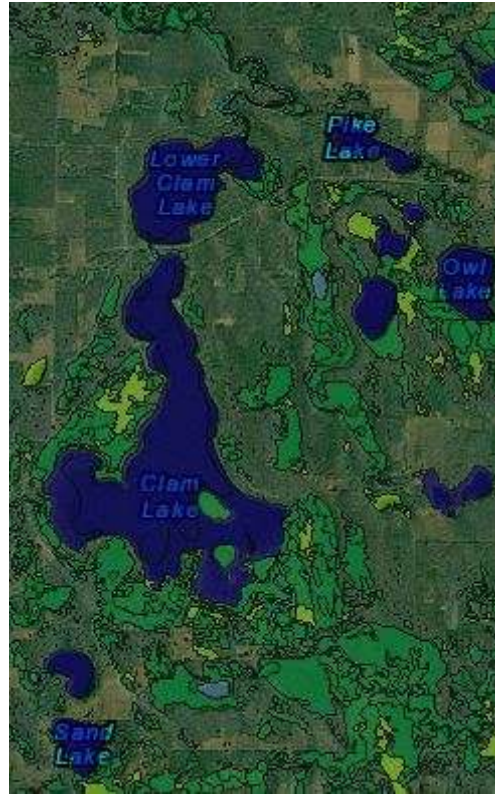
According to the National Wetland Inventory, emergent, forested/shrub and freshwater, emergent wetlands are present in the Clam Lakes watershed. The majority of the wetland borders the lakes and tributary streams and have a direct hydrologic connection to the lakes (Figure 4). Emergent wetlands (light green) are wetlands with saturated soil and are dominated by grasses such as reedtop and reed canary grass, and by forbs such as giant goldenrod. Forested/shrub wetlands (darker green) are wetlands dominated by mature conifers and lowland hardwood trees. Forested/shrub wetlands are the dominant form of wetlands in the watershed and are important for stormwater and floodwater retention and provide habitat for various wildlife.

Figure 4 – Clam Lakes Wetlands (4)

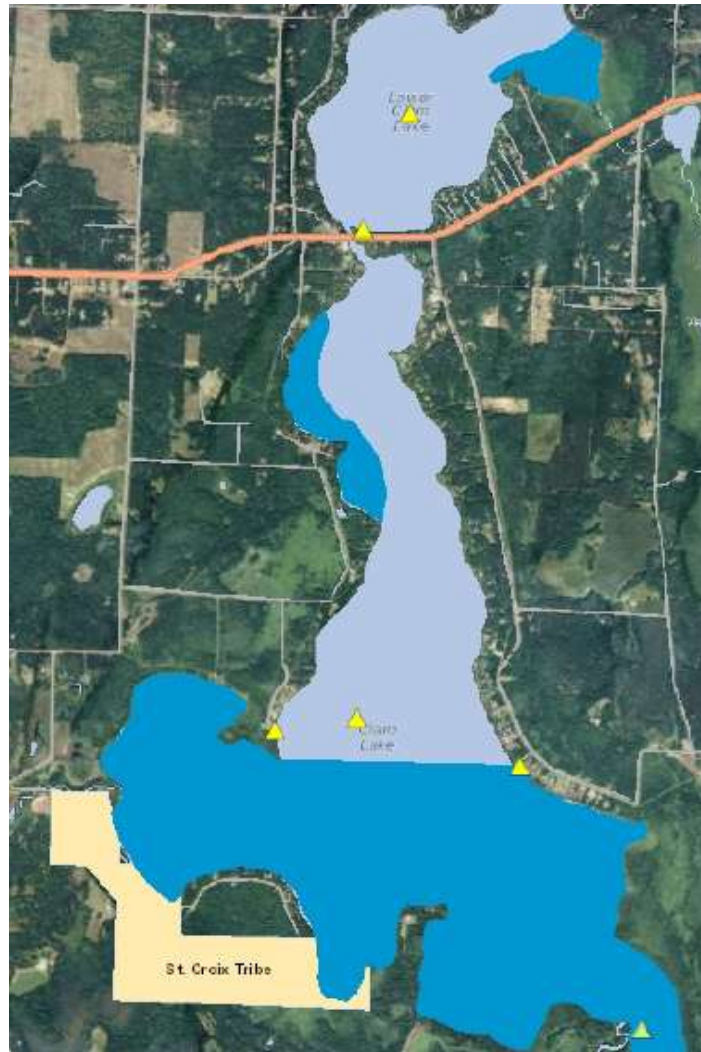
Figure 5 – Sensitive Areas (dark blue) in Upper and Lower Clam Lakes (5)

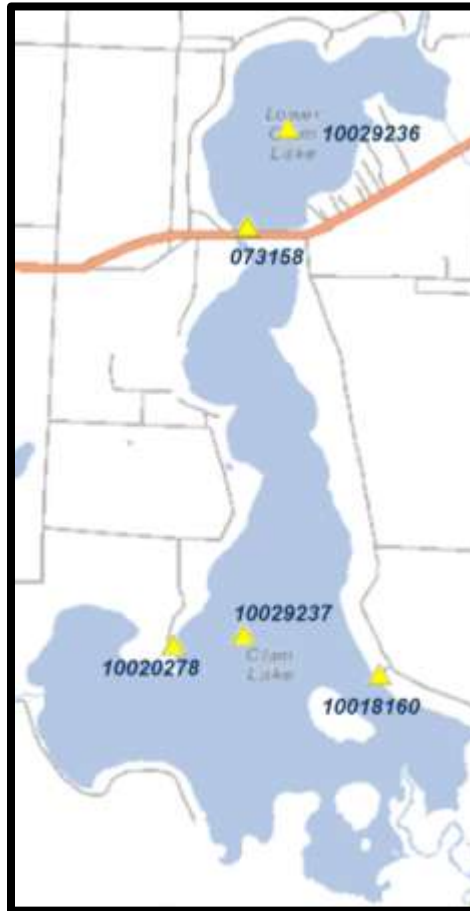
Figure 7 – Monitoring Stations Map for Lower & Upper Clam Lakes

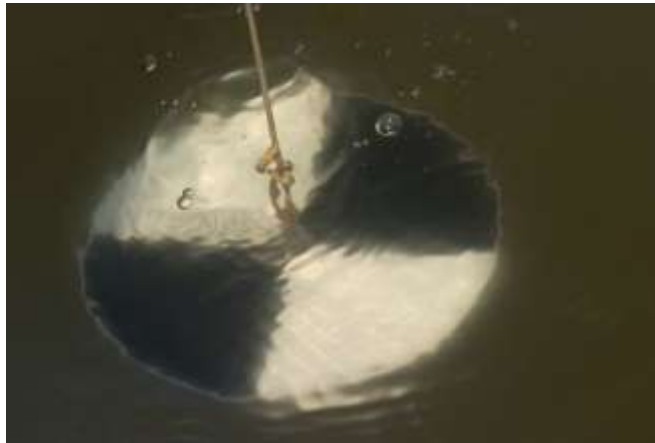
Water clarity is a measurement of how deep sunlight can penetrate into the waters of a lake. It can be measured in a number of ways, the most common being an 8" disk divided into four sections, two black and two white, lowered into the lake water from the surface by a rope marked in measurable increments (Figure 8). The water clarity reading is the point at which the Secchi disk (named for its inventor) when lowered into the water can no longer be seen from the surface of the lake. Water color (like dark water stained by tannins from nearby bogs and wetlands), particles suspended in the water column (like sediment or algae), and weather conditions (cloudy, windy, or sunlight) can impact how deep a Secchi disk can be seen down in the water. Some lakes have water clarity readings of just a few inches, while other lakes have conditions that allow the Secchi disk to be seen for dozens of feet before it disappears from view.

Figure 8 – Black and White Secchi Disk for measuring Water Clarity

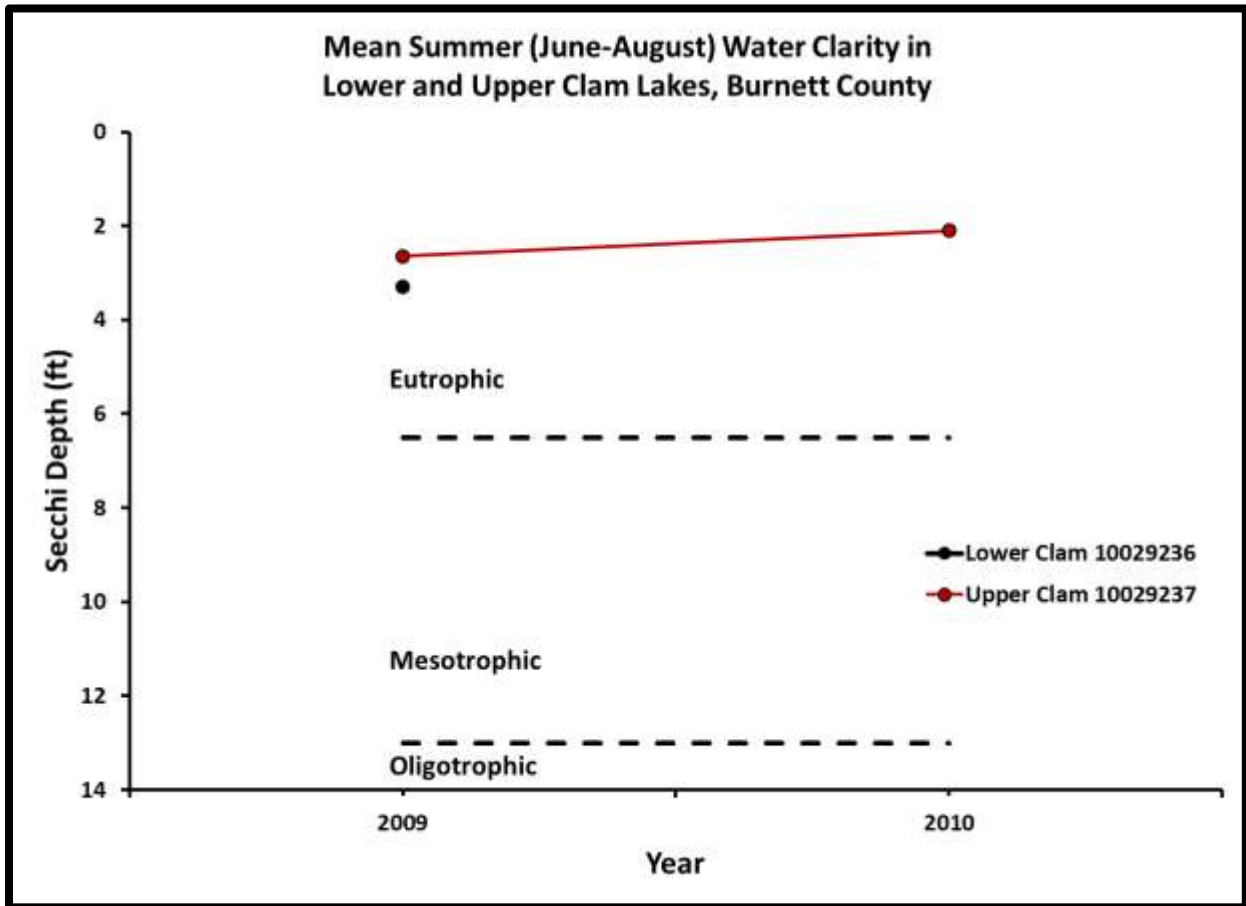
Secchi depth values for the St. Croix Reservation vicinity compiled by Saad & Robertson (2000) range from 2.0 to 14.1 feet with an average of 7.3 feet, therefore classifying the “average” lake in the region as mesotrophic. Hence, the Clam Lakes have water clarity that is lower than average for waters in the region.

Figure 9 – Secchi Depth in Lower and Upper Clam Lakes

The average summer (June - August) Secchi reading on Upper Clam Lake collected by SCTES from 2001-2013 is 2.74 ft.

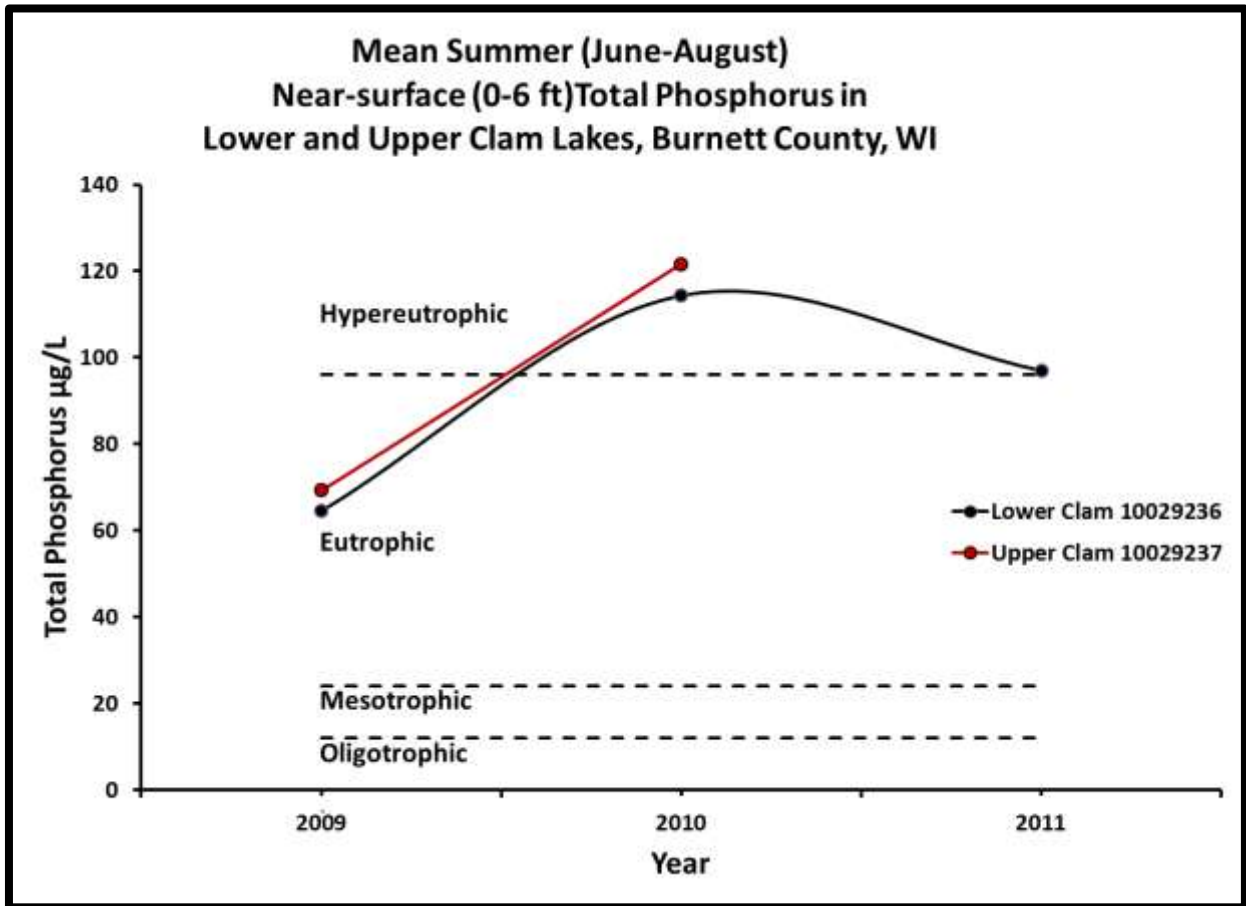
Phosphorus values for the St. Croix Reservation vicinity range from 10µg/L to 150µg/L with an average of 29µg/L (2). The “average” lake in the region is eutrophic. The Clam Lakes have higher than average phosphorus concentrations when compared to waters in the region.

Figure 10 – Total Phosphorus in Lower and Upper Clam Lakes

SCTES data for total phosphorus collected between 2001 and 2013 ranged from 58µg/L to 158µg/L with a mean of 101µg/L supporting the CLMN records indicating that the Clam Lakes are eutrophic, bordering on hyper-eutrophic.

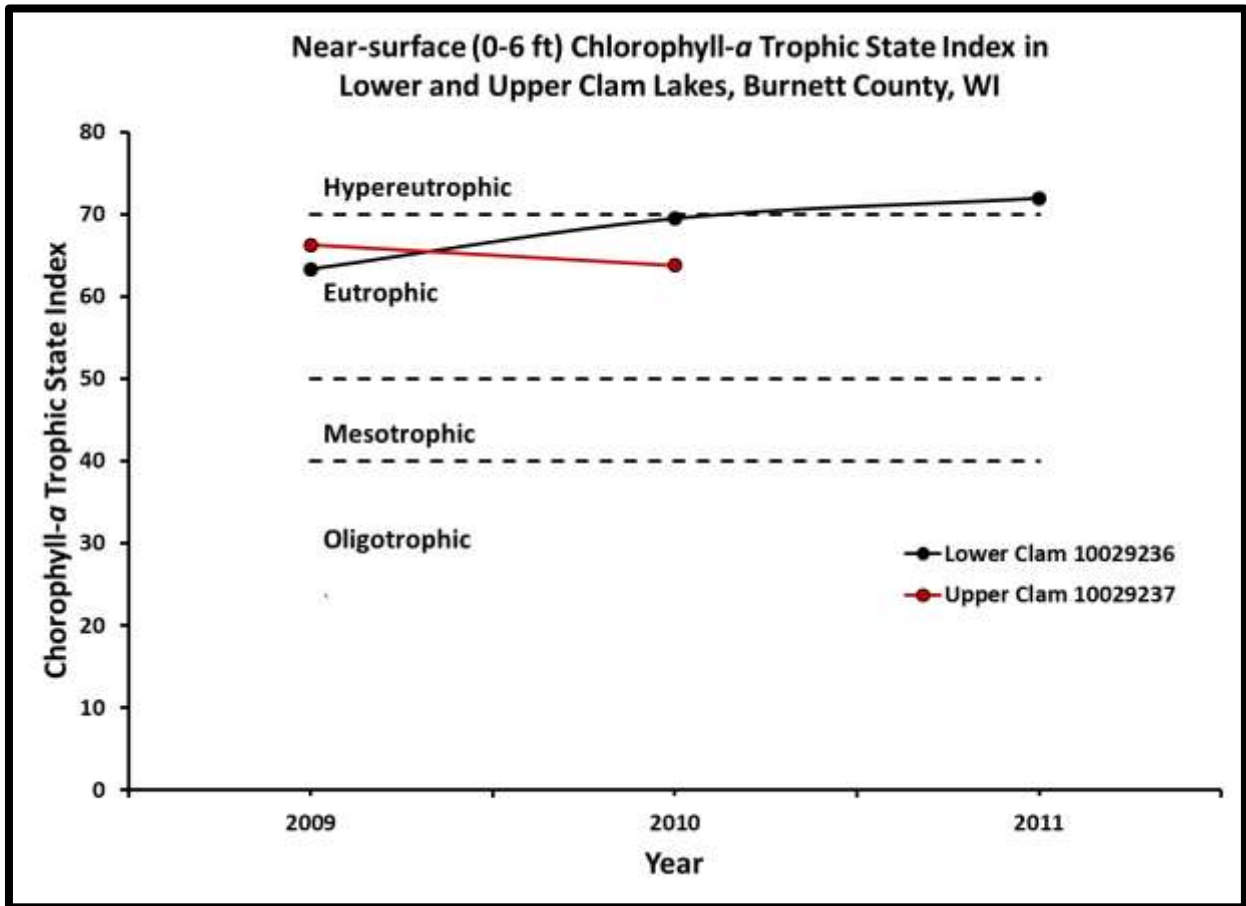
TSI values for Chlorophyll-*a* in the St. Croix Reservation vicinity ranges from 36 (1.7µg/L) to 65 (32µg/L) with an average of 53 (9.8µg/L) (2). The “average” lake in the region is eutrophic. The Clam Lakes have higher than average chlorophyll-*a* concentrations when compared to waters in the region.

Figure 11 – Chlorophyll-a TSI Values in Lower and Upper Clam Lakes

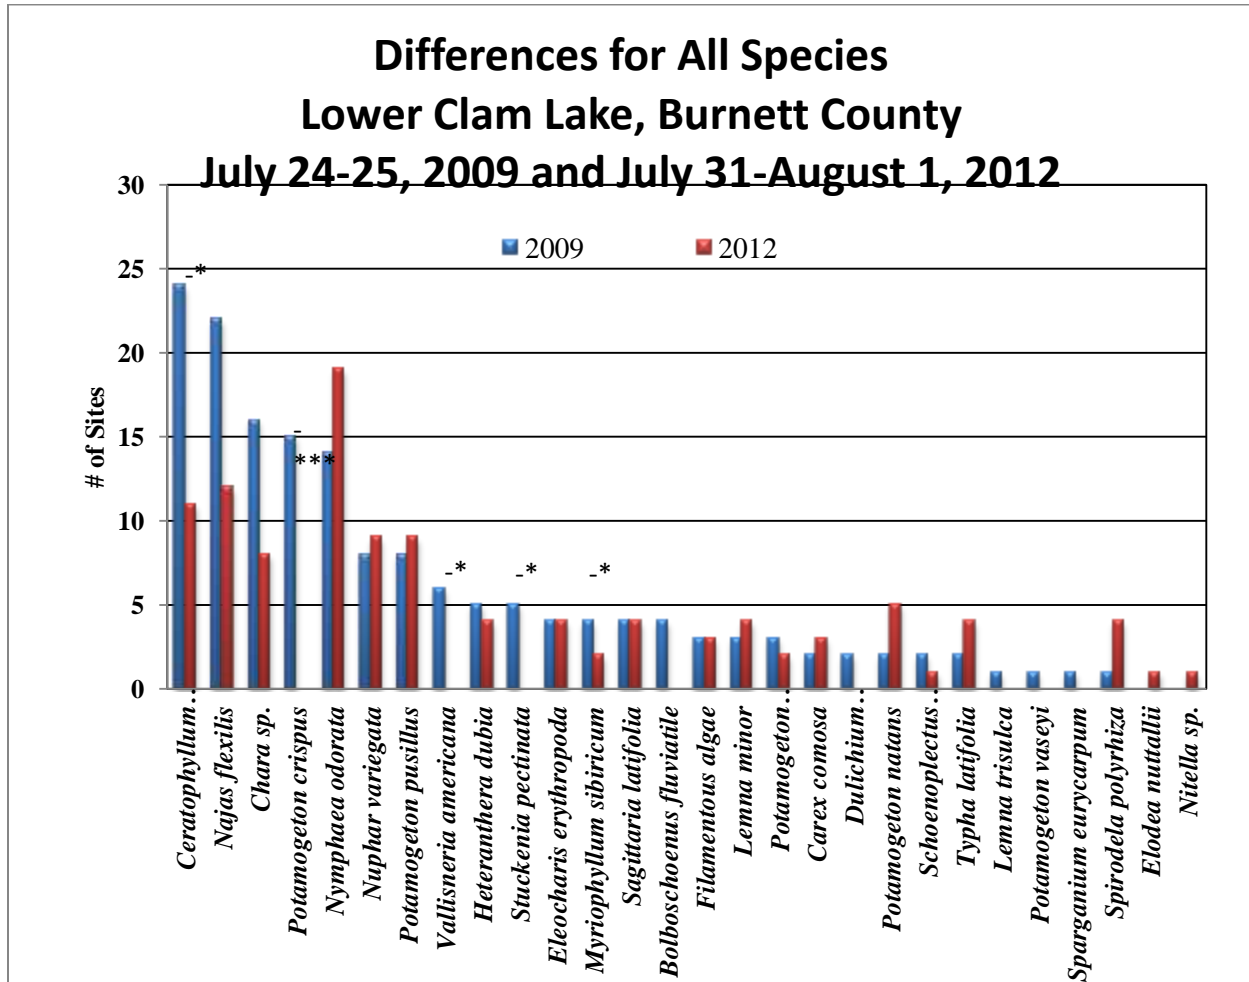
Comparing the two surveys found a significant decrease in coontail, wild celery, sago pondweed, and river bulrush. It also showed a highly significant decrease in curly-leaf pondweed (Figure 24).

Figure 24 – 2009 – 2012 Macrophyte Changes on Lower Clam Lake

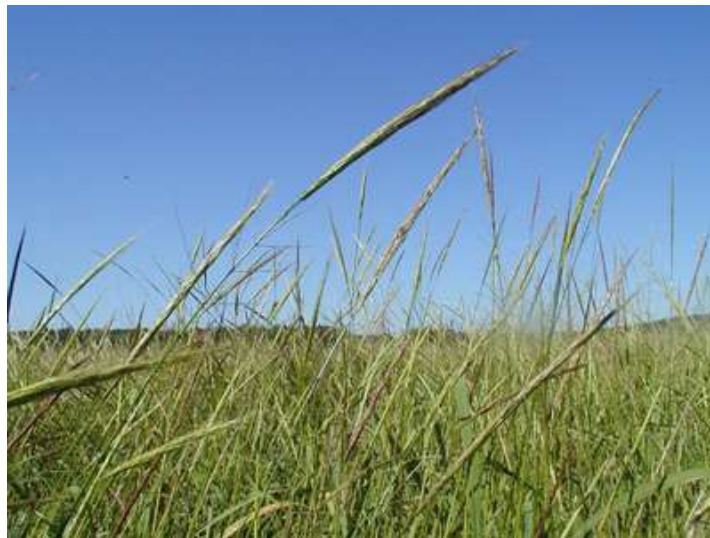
Figure 26 – Wild Rice

Wild rice is an annual aquatic grass that produces seed that is a nutritious source of food for wildlife and people (Figure 26). As a native food crop, it has a tremendous amount of cultural significance to the Wisconsin and Minnesota Native American Nations. Wild rice pulls large amounts of nutrients from the sediment in a single year and the stalks provide a place for filamentous algae and other small macrophytes to attach and grow. These small macrophytes pull phosphorous in its dissolved state directly from the water. Wild rice can benefit water quality, provide habitat for wildlife, and help minimize substrate re-suspension and shoreland erosion.

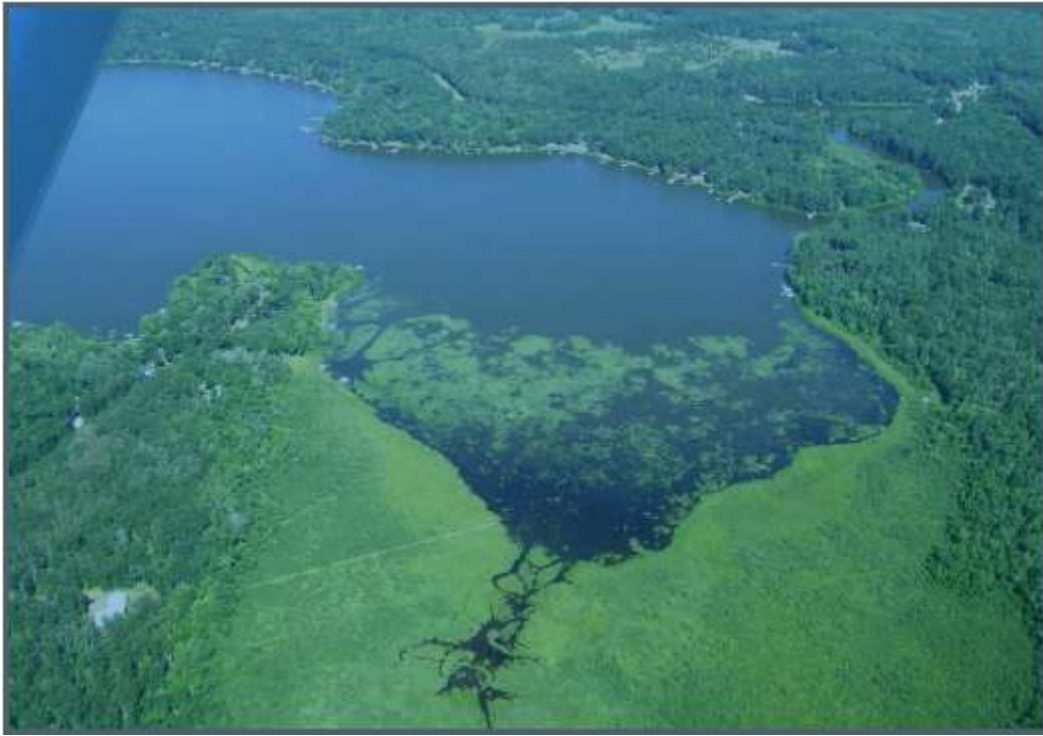
Although Upper Clam Lake is well known for its expansive rice beds, the smaller beds on Lower Clam tend to be overlooked. The rice on Lower Clam is largely limited to the bay east of the outlet which is visible at the upper right in the photo in Figure 27. There are anecdotal reports that these beds were seeded by local residents fairly recently. They are located in an area with little lakeshore development. It remains to be seen if these beds are facing the same decline that has been witnessed on the Upper Clam beds, whose most recent appreciable crop was in 2006. The Tribal Watch Status for Lower Clam is high due to decline concerns.

Figure 27 – Wild Rice in the Bay East of the Outlet on Lower Clam Lake in 2008 (GLIFWC, 2010)

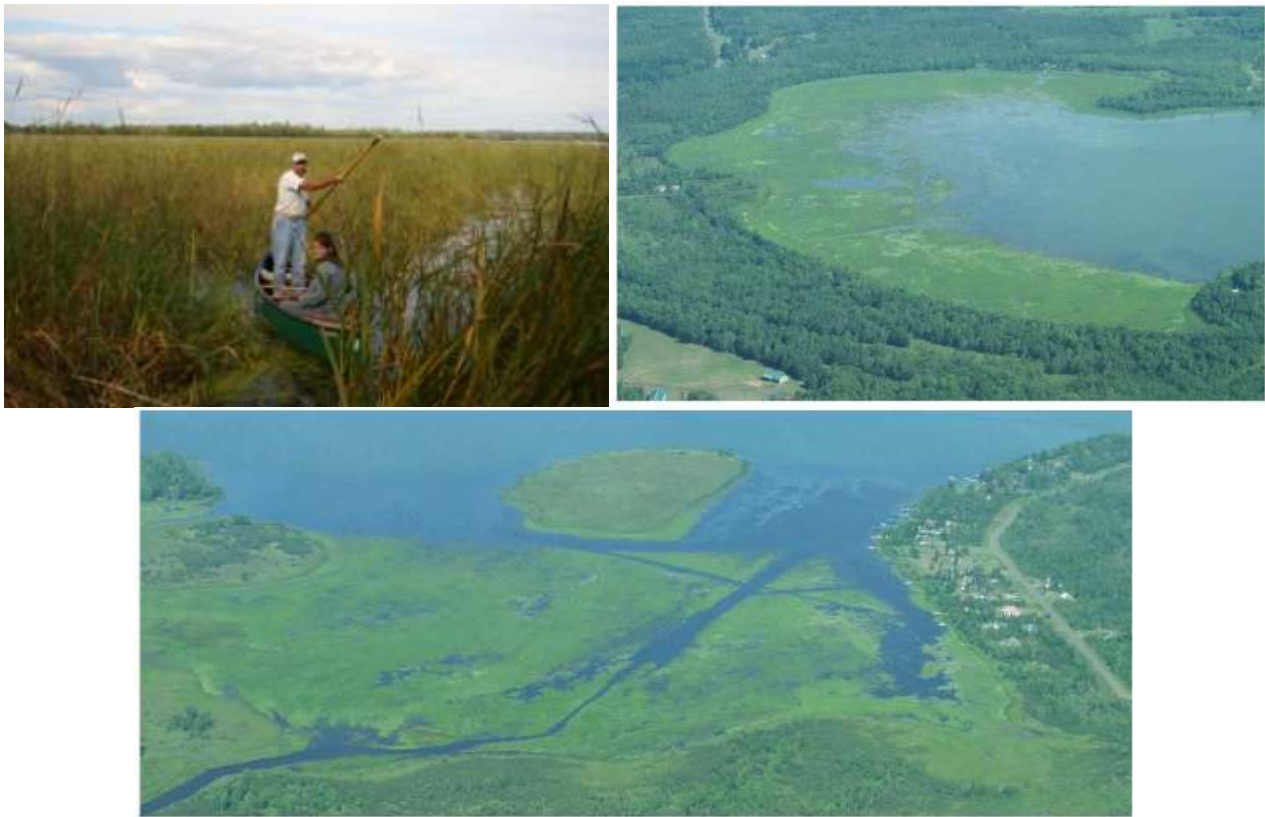
Figure 28 – Wild Rice in the SW Bay in 2006 and 2007 (top) and in the SE Bay in 2007 (bottom) on Upper Clam Lake (GLIFWC, 2010)

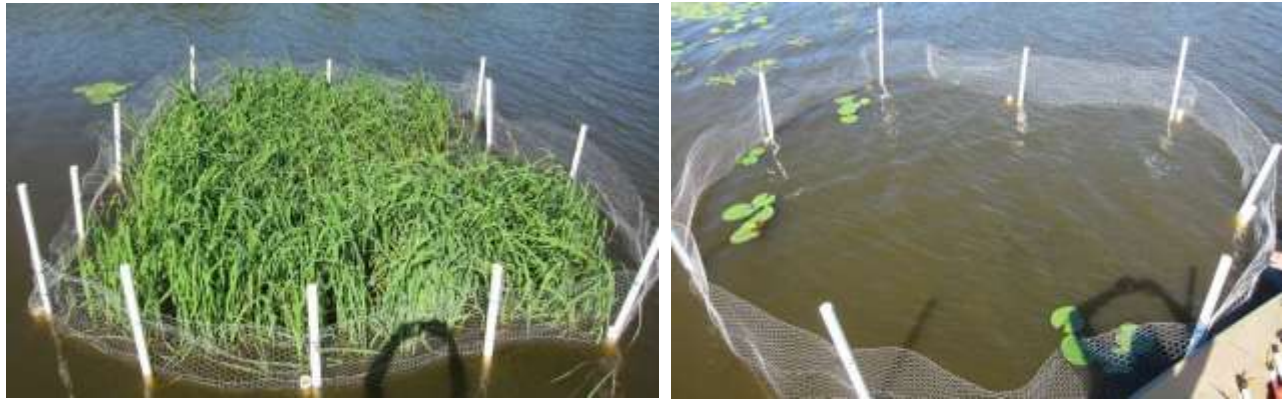
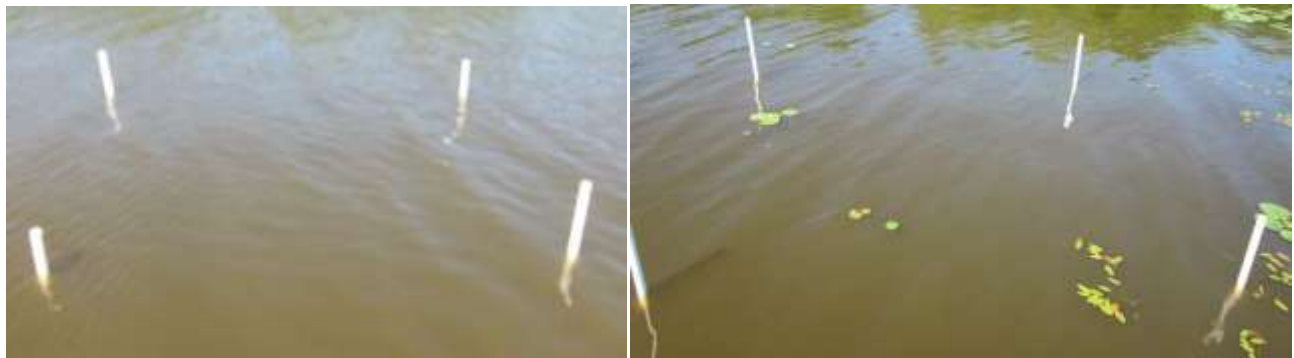
A meeting was held on January 19, 2010 at the Tribal Resources Office in Hertel, WI to discuss 2009 findings on the Clam Lakes and what to do in 2010. The local WDNR Fish Manager, SCTES biologists, GLIFWC Biologists, Clam CLPRD representatives, SEH, and others were in attendance. Additional carp studies were completed in 2010 by both the WDNR and Tribal Resources. SCTES also completed a more comprehensive wild rice survey of the system in 2010. In another study completed in 2010 (22), a system of carp exclusion cages were set up by SCTES and WDNR resources in Upper Clam Lake in an attempt to determine what impact the carp may be having in the system. Several of the cages were seeded with rice (Figures 30 & 31).

Figure 30 – Seeded and Fenced (left) and Unseeded and Fenced (right) Wild Rice Exclosures installed in 2010

Figure 31 – Seeded and Unfenced (left) and Unseeded and Unfenced (right) Wild Rice Exclosures installed in 2010

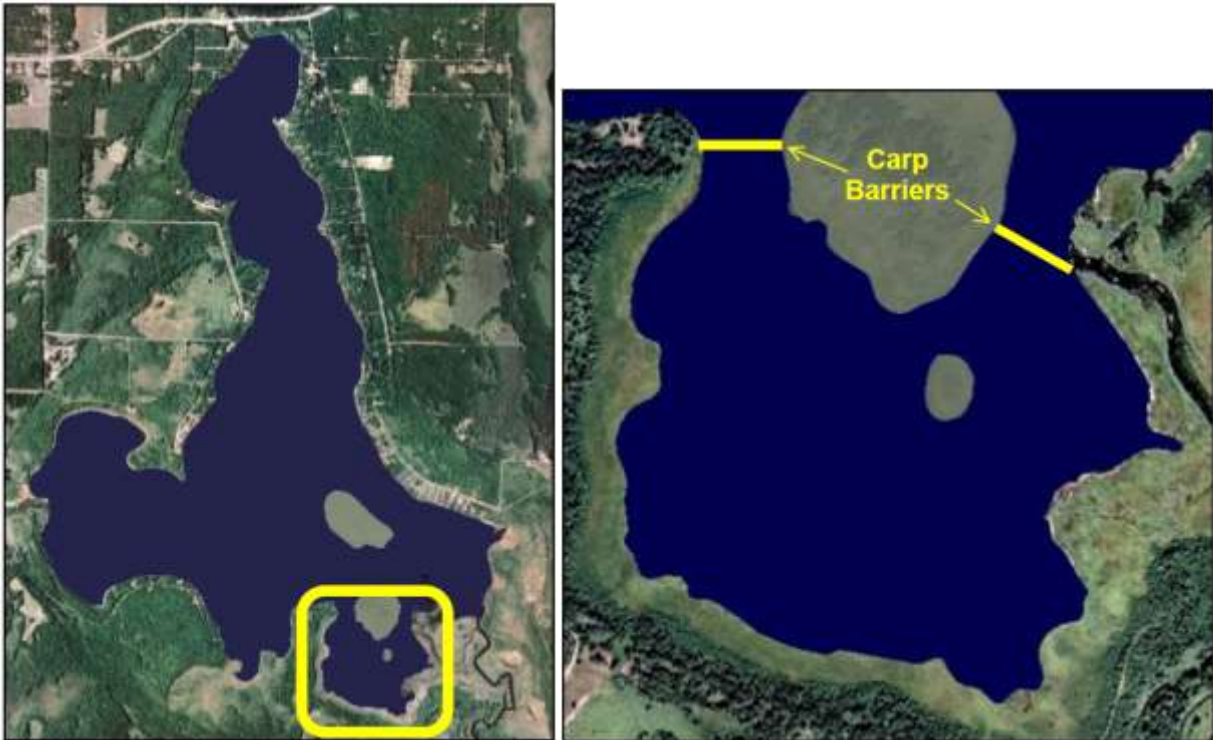
In an effort to protect and preserve the remaining wild rice beds in the southern most bay of Upper Clam Lake, in April 2011 staff from SCTES installed carp barriers that consisted of two nets with surface floats and bottom weights stretched across the two narrow channels that connect the southern bay of Upper Clam Lake to the main basin of the Lake (Figure 32). These barriers were in place before carp moved into shallow areas to spawn, but carp were not removed from behind the barrier.

Figure 32 – Wild Rice Protection Barriers on the SE Bay of Upper Clam Lake

The recommendation to keep the carp barrier across the southeast bay of Upper Clam Lake was heeded and in each of the last two years they have been reinstalled in the spring of the year before carp have a chance to move into the area. Survey work done in 2012 and again in 2103 show that by keeping carp out of the SE Bay, the wild rice has rebounded nicely (Figure 33). Further consideration should be given to fencing carp out of other areas of both lakes to help restore wild rice and other native plants.

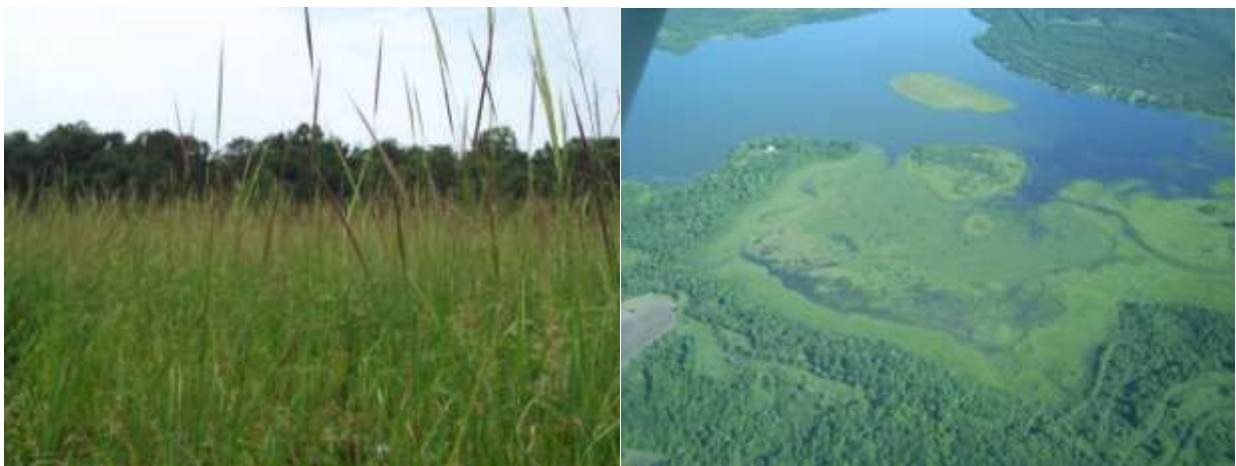
Figure 33 – Wild Rice in the SE Bay of Upper Clam Lake in 2012 (left, ERS) and 2013 (right, GLIFWC)

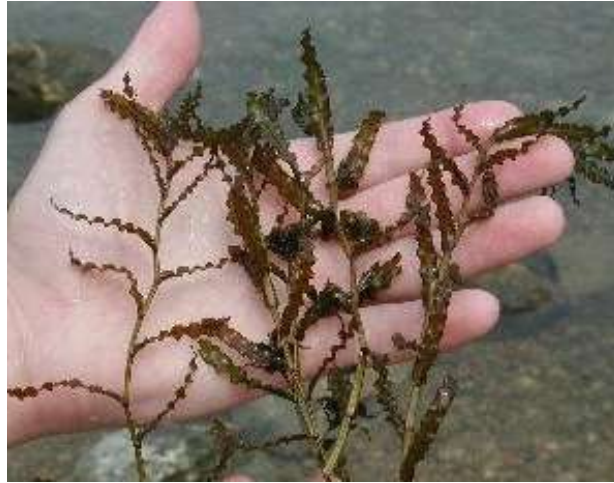
Figure 34 – Curly-leaf Pondweed

The leaves of curly-leaf pondweed are reddish-green, oblong, and about 3 inches long, with distinct wavy edges that are finely toothed (Figure 34). The stem of the plant is flat, reddish-brown and grows from 1 to 3 feet long. Curly-leaf is commonly found in alkaline and high nutrient waters, preferring soft substrate and shallow water depths. It tolerates low light and low water temperatures.

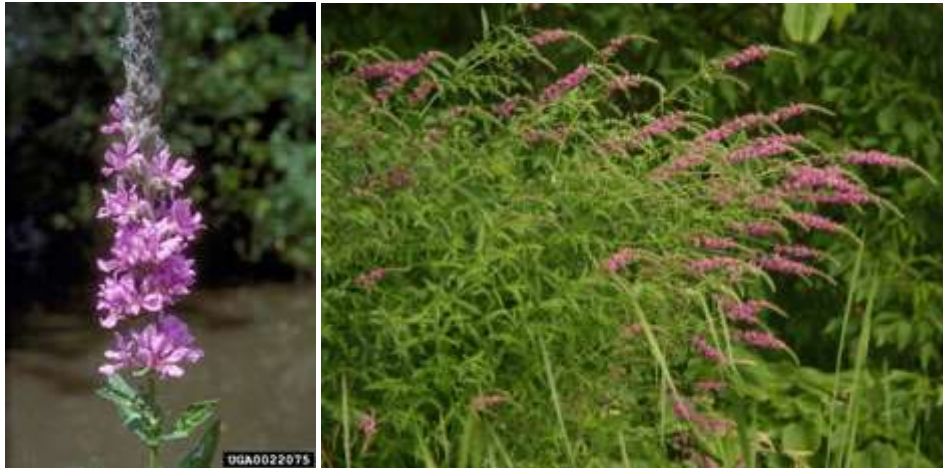
Figure 36 – Purple Loosestrife

Purple loosestrife is a perennial herb 3 to 7 feet tall with a dense bushy growth of 1 to 50 stems. The stems, which range from green to purple, die back each year. Showy flowers vary from purple to magenta; possess 5 to 6 petals aggregated into numerous long spikes, and bloom from July to September. It is easiest to distinguish in late July and August as it has a very distinctive flowering head. Leaves are opposite, nearly linear, and attached to four-sided stems without stalks. It has a large, woody taproot with fibrous rhizomes that form a dense mat (Figure 36).

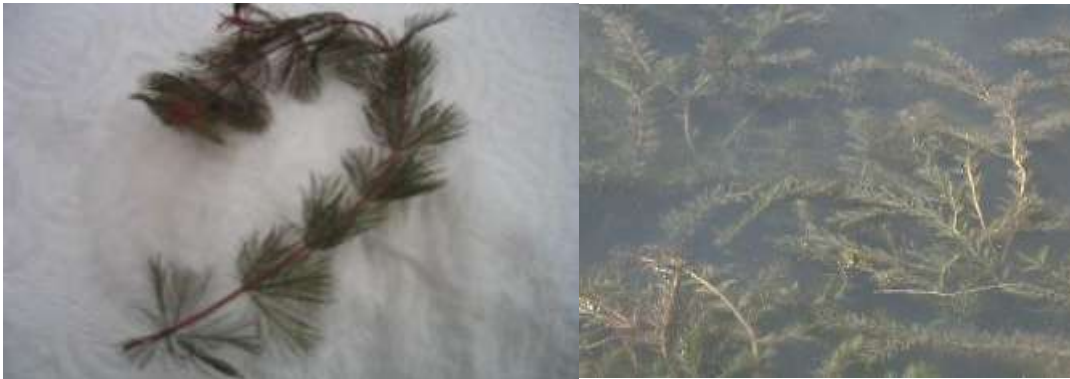
Figure 37 – Eurasian Watermilfoil

EWM is a submerged aquatic plant native to Europe, Asia, and northern Africa (Figure 37). Although EWM was not found in the Clam Lakes during extensive surveying in 2009 and 2012, its introduction remains a concern. As a popular destination in northwestern Wisconsin, the Clam Lakes are a prime candidate for the introduction of EWM via boat traffic. And due to the impacts on native plants caused by the carp population, there is little native vegetation to help keep EWM at bay if it were to get introduced.

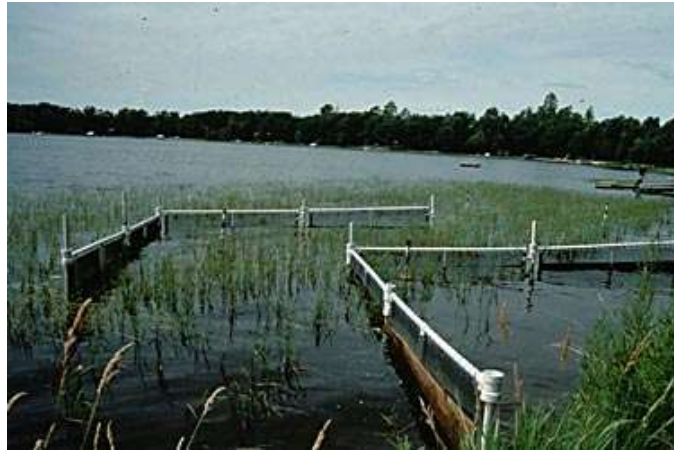
Artificially reintroducing native aquatic plants is often difficult and costly and requires a fairly large source of new plants and substantial short-term labor for collecting, planting, and maintaining the stock. Maintenance of plantings may require protection from fish and birds and temporary stabilization and protection of sediment in the planting area from wind and waves (Figure 41).

Figure 41 – “Buffer Blocker” System for Protecting Native Macrophyte Plantings
