**Curly-leaf pondweed (*Potamogeton crispus*)
Point-intercept and Bed Mapping Surveys, and
Warm-water Point-intercept Macrophyte Survey
Upper Clam Lake (WBIC: 2656200)
Burnett County, Wisconsin**

Project Initiated by: The Wisconsin Department of Natural Resources, the Clam Lake Protection and Rehabilitation District, and Lake Education and Planning Services, LLC

Endangered Resource Services, LLC

June 1, 3, 17, and August 29-September 2, 2019

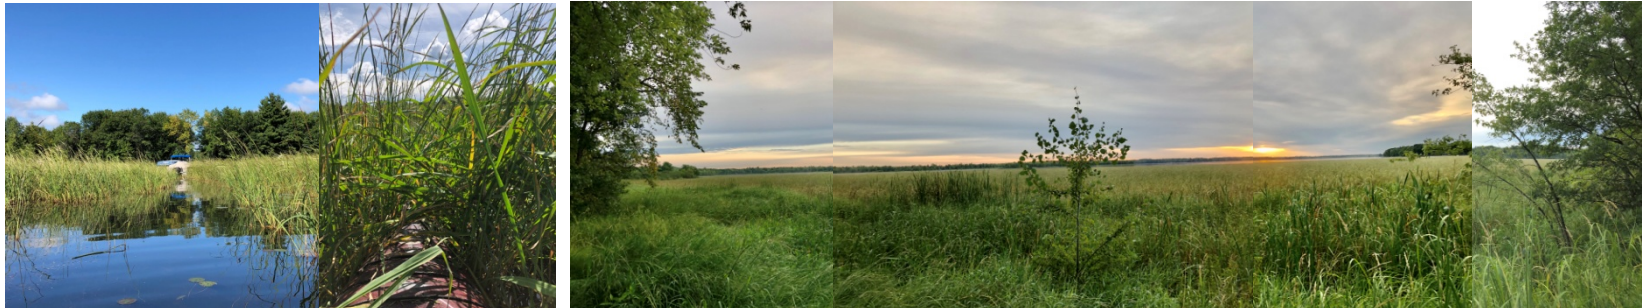
In 2019, rice underwent a highly significant expansion ($p<0.001$) in distribution. Present at 137 points with 24 additional visual sightings, it was tied for Water star-grass as the fourth most widely distributed species (22.64% of points with plants present/20.54% of the littoral zone). Of these, we rated 68 a rake fullness of 3, 39 a 2, and the remaining 30 a 1 for a mean rake fullness of 2.28 (Figure 18) (Appendix VII). Although this was also an increase in density from 2016, it was not significant ($p=0.14$). Most of the beds offered significant human harvest potential, and we found many places were so dense that using a canoe and pole was impossible. This forced us to survey by kayak, and it took us three days to push and pull our way through the “forest” of rice. Although wonderful for wildlife and those harvesting, these dense areas of rice clearly made things difficult for those accessing the lake from their shorelines in these southern bays; especially if they were doing so infrequently (Figure 19).

Broken out by region, the southwest bay had more rice than at any point since our first survey in 2009. Viewed from Lone Star Road on the bay’s southwest side, a wall of rice extended out from shore (Figure 19). On the open water margin, the rice was more fragmented, but the majority of areas were still extremely dense (Figure 20), and harvest trails crisscrossed the bed.

**Figure 19: Shoreline Impairment and Typical Density in the Southwest Bay –
Panorama of Northern Wild Rice on the Southwest Shoreline of the Southwest Bay 8/31/19**
